# **BISBEE MUNICIPAL AIRPORT**

### **AIRPORT MASTER PLAN - 1999**

#### **INTRODUCTION, BACKGROUND & INVENTORY**

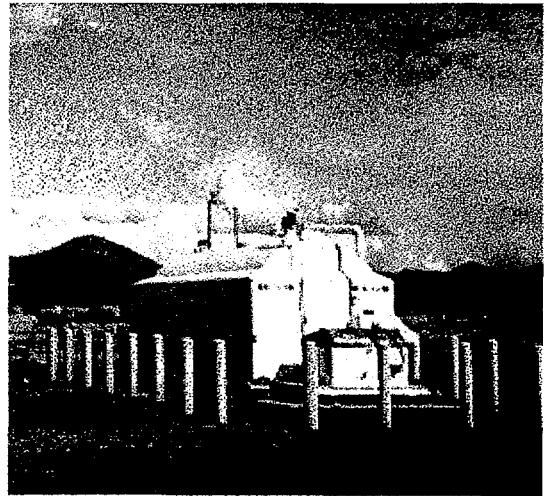
The existing aircraft fueling system consists of an above-ground tank (100LL) and self-service pumps, located adjacent to the Aircraft Parking Apron. The tank and delivery equipment is located on a 10' x 30' concrete slab and is protected by pipe bollards. The fuel system was constructed in 1995 and is in Good condition. It is in compliance with all currently applicable environmental and regulatory codes.

*The Above-Ground Fuel System*

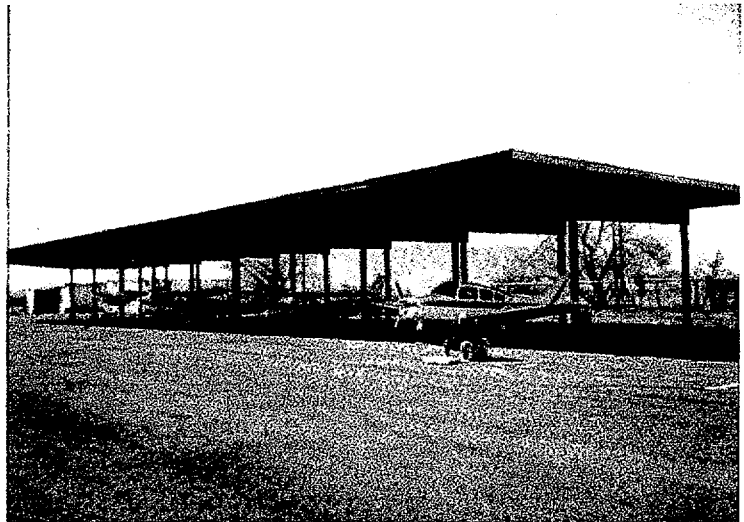
*Building #7 - the south T-Shades  
(see discussion on Page 1-28)*

Building #6 is located on the north side of the terminal area. It is 42' wide x 162' long (roof dimensions) and can accommodate 5 parked aircraft. Building #7 is located on the south side of the terminal area. It is 42' wide x 205' long (roof dimensions) and can accommodate 6 aircraft. They are both in Good condition.

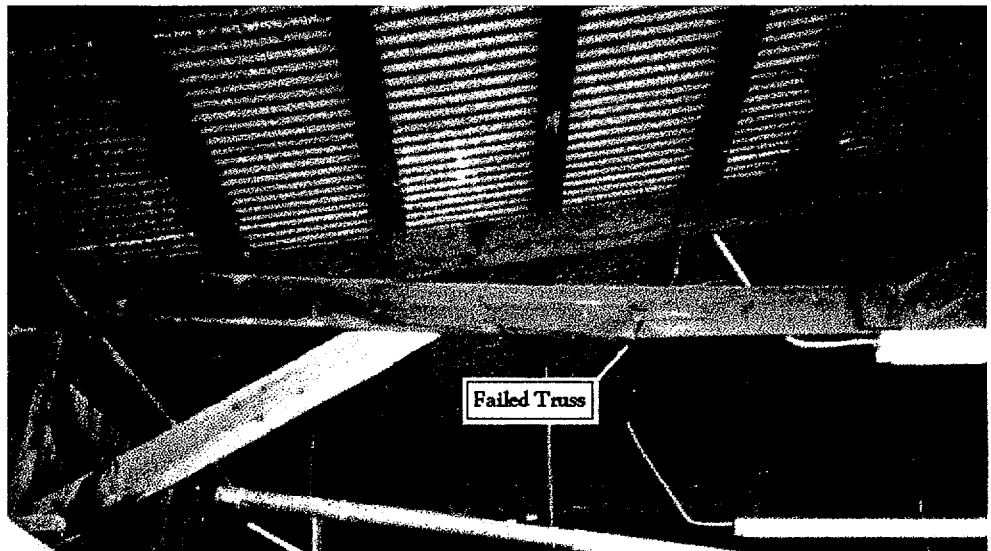
*Detail of a failed wood truss in Hangar Building #4 (see discussion on Page 1-27)*

The foundation, concrete slab and electrical service equipment and wiring were found to be in Good condition. However, the wood framed roof system shows signs of structural distress, with cracked and deformed framing members. These are characterized as in Poor condition. The frame sidewall extensions, corrugated steel roofing and siding, doors, hardware and lighting were also found to be in Poor condition. The 12' x 16' interior room shows evidence of rodent damage to the walls and floor plates.

Building #4 is considered to be in generally Poor condition. The masonry walls, foundation and slab could be salvaged. The building could be made serviceable with the installation of new side wall extensions, roof framing and door, and upgraded lighting.

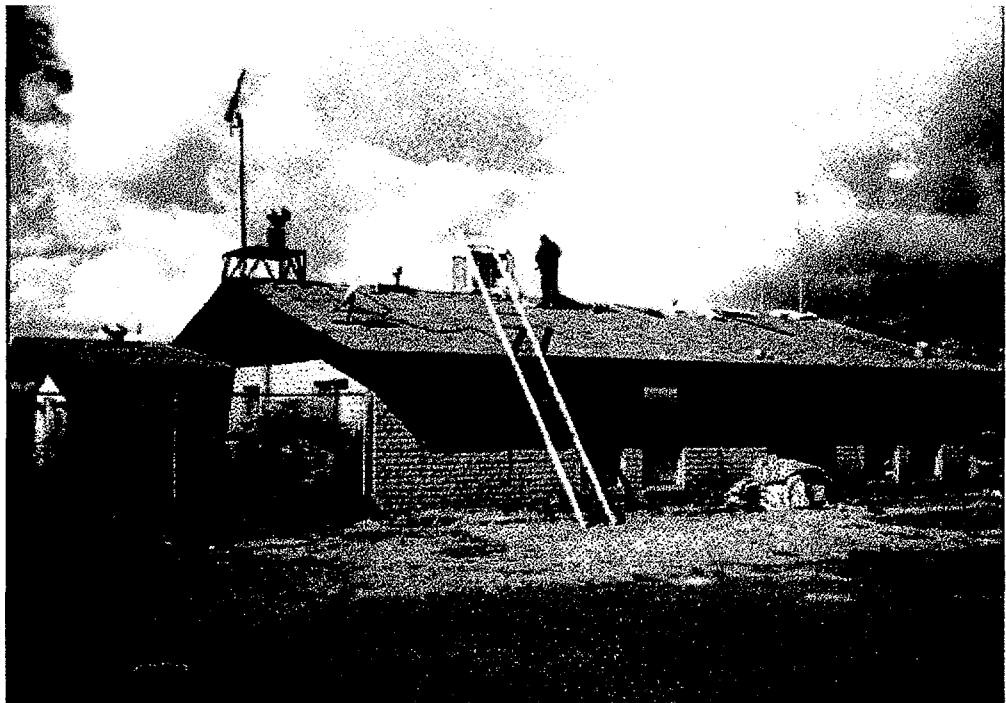
The building is of masonry construction, using 8" thick x 4"x 16" Concrete Masonry Units with slump block fascia. The roofing materials were replaced in January of 1999. The structure, plumbing, electrical and gas service and building exterior and roof were found to be in Good condition. The interior condition and adequacy for its present use is Fair and adequate handicapped access is not provided (see below).

*The airport Terminal (Building #1) in the process of reroofing.*

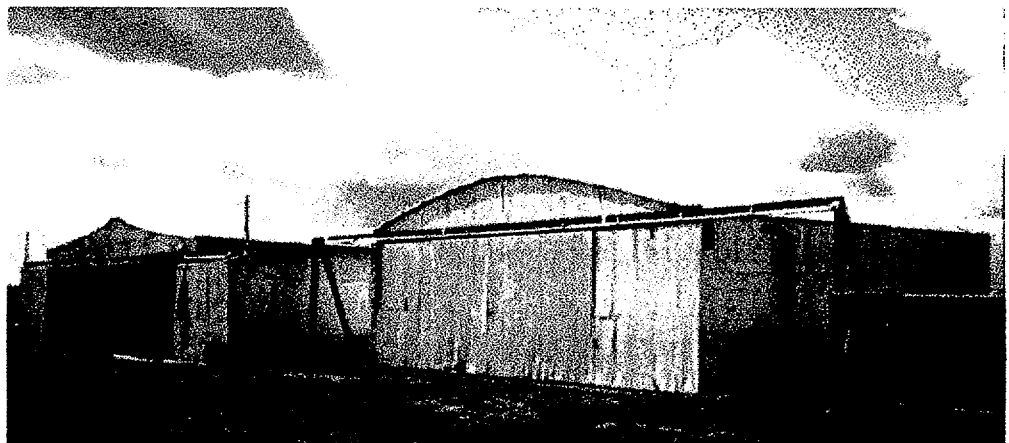
The steel pipe wall, roof and door framing members exhibit extensive corrosion. Building #3 is considered to be in generally Poor condition.

*Hangar Buildings #3 (foreground) and #4*

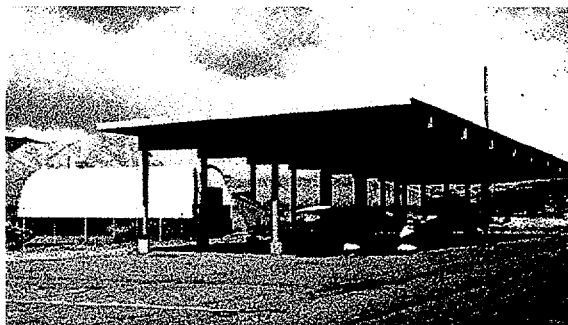
*T-Shades (Building #6) with Quonset Building #2 in the background.*

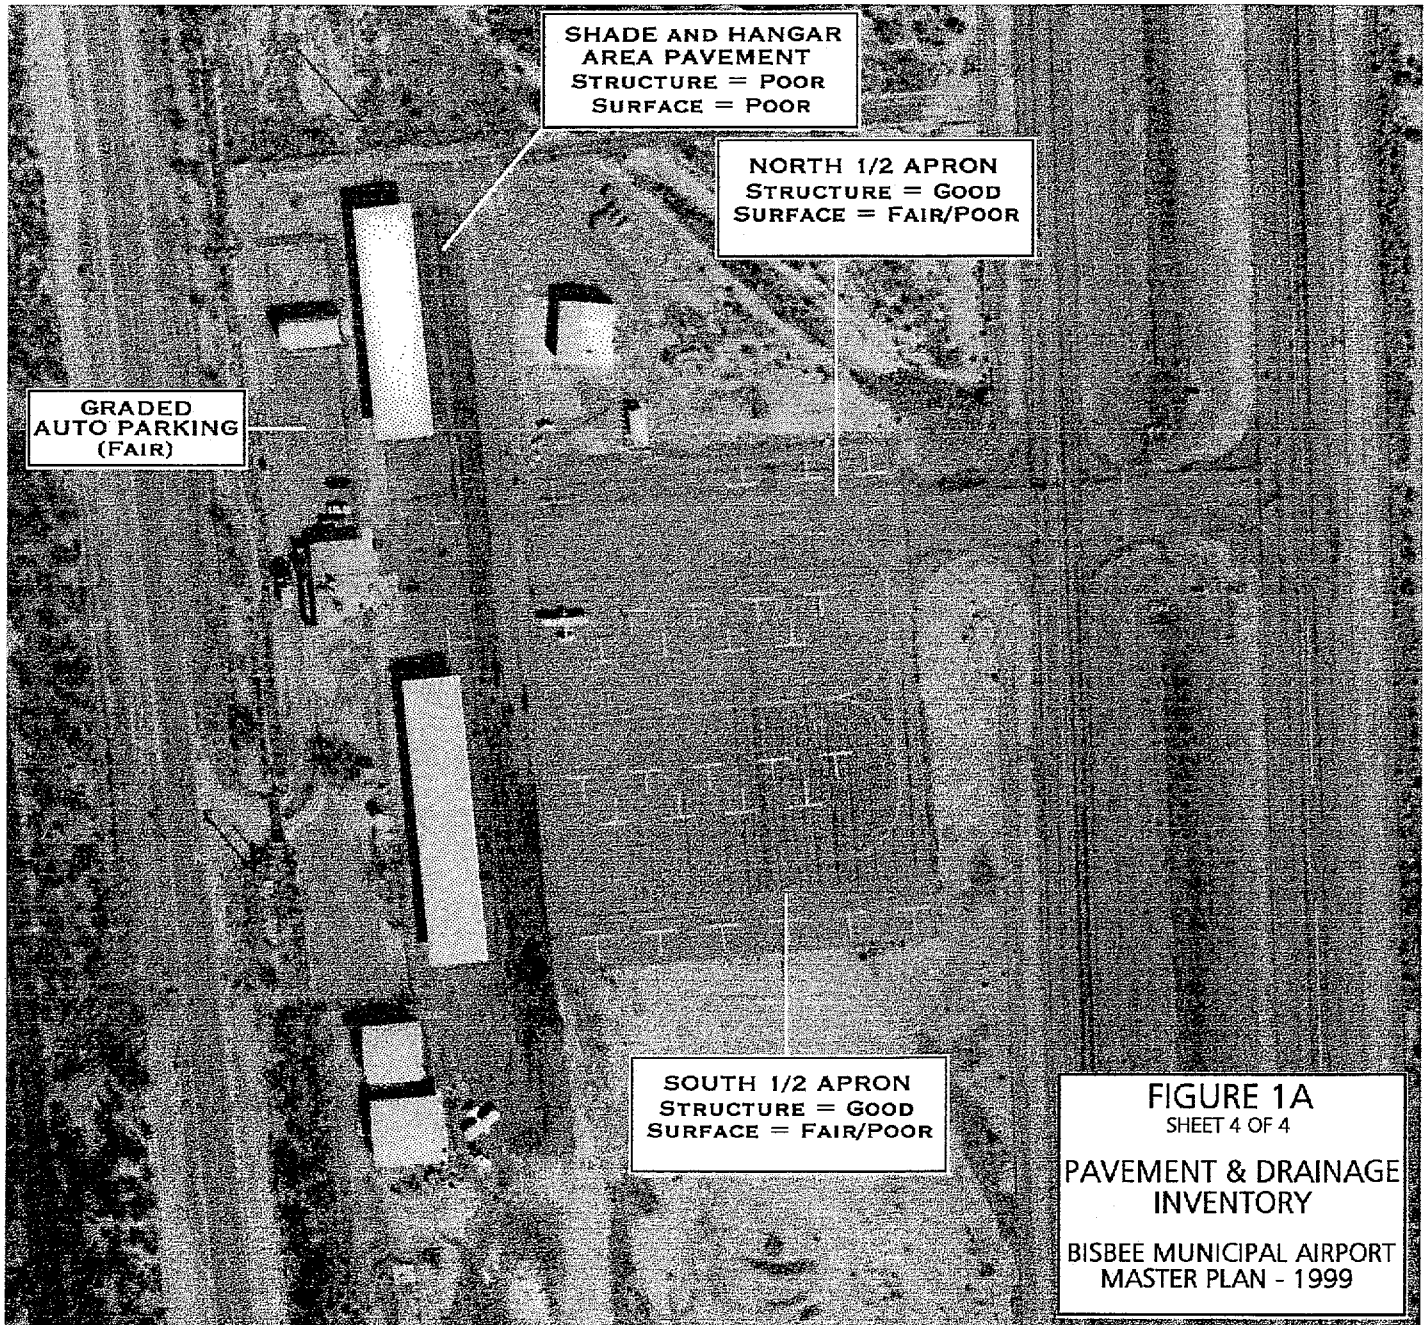
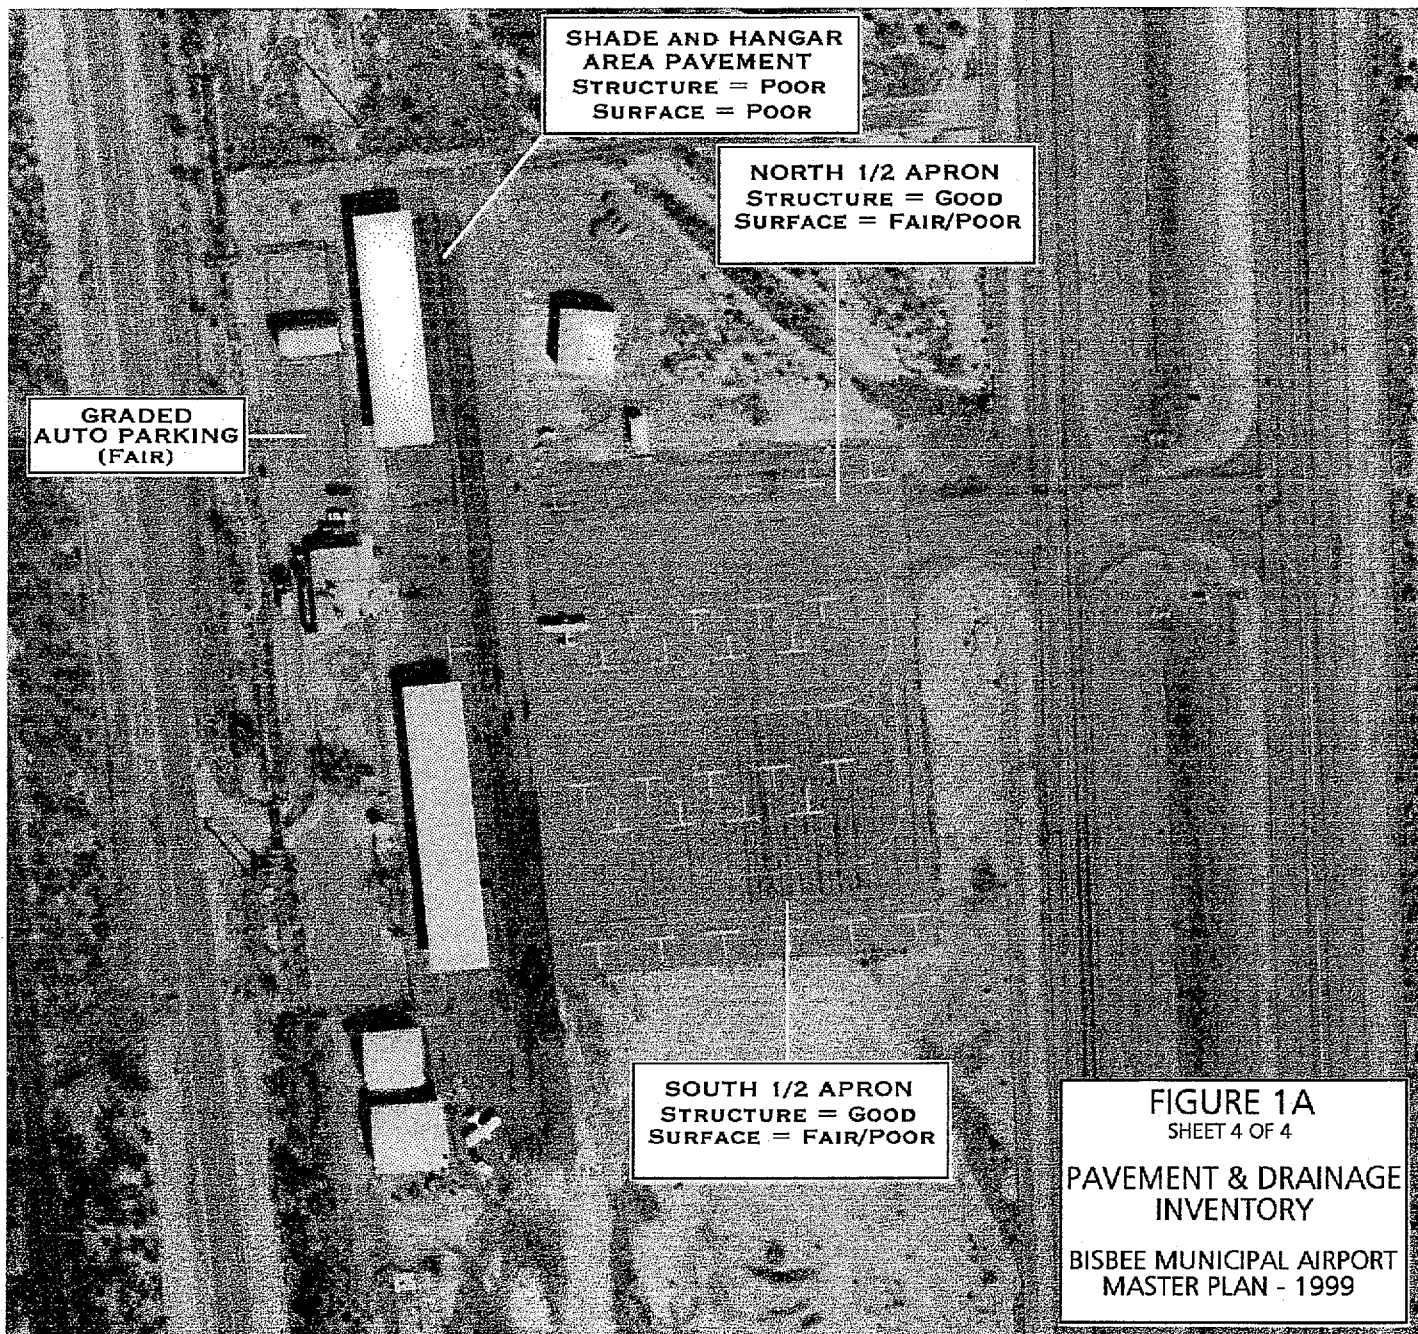
PAVEMENT & DRAINAGE  
INVENTORY

TAXIWAY A-6  
STRUCTURE = GOOD  
SURFACE = FAIR/POOR  
3-36" RCP = GOOD

SHADE AND HANGAR  
AREA PAVEMENT  
STRUCTURE = POOR  
SURFACE = POOR

NORTH 1/2 APRON  
STRUCTURE = GOOD  
SURFACE = FAIR/POOR
